A slope stability problem in Hong Kong

7.1 Introduction

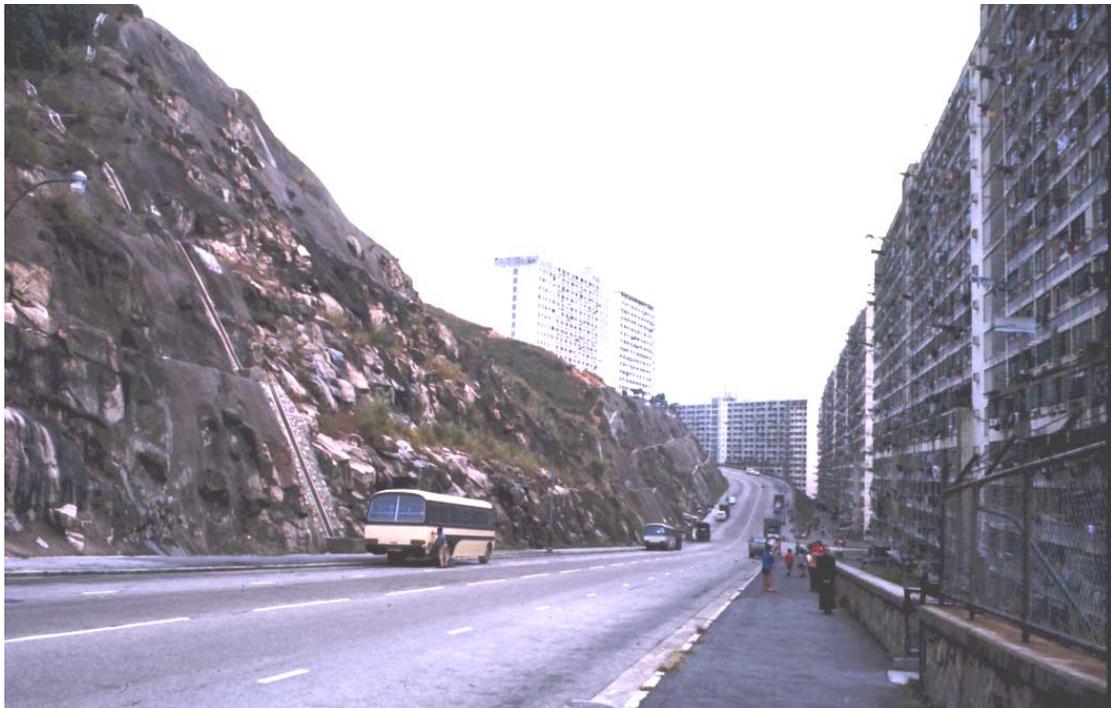
During this review, a rock slope on Sau Mau Ping Road in Kowloon was identified as being potentially unstable. The stability of this particular slope was critical because it was located immediately across the road from two blocks of apartments, each housing approximately 5,000 people.

Figure 7.1: A view down Sau Mau Ping Road in Kowloon showing apartment blocks across the road from the steep rock slopes.

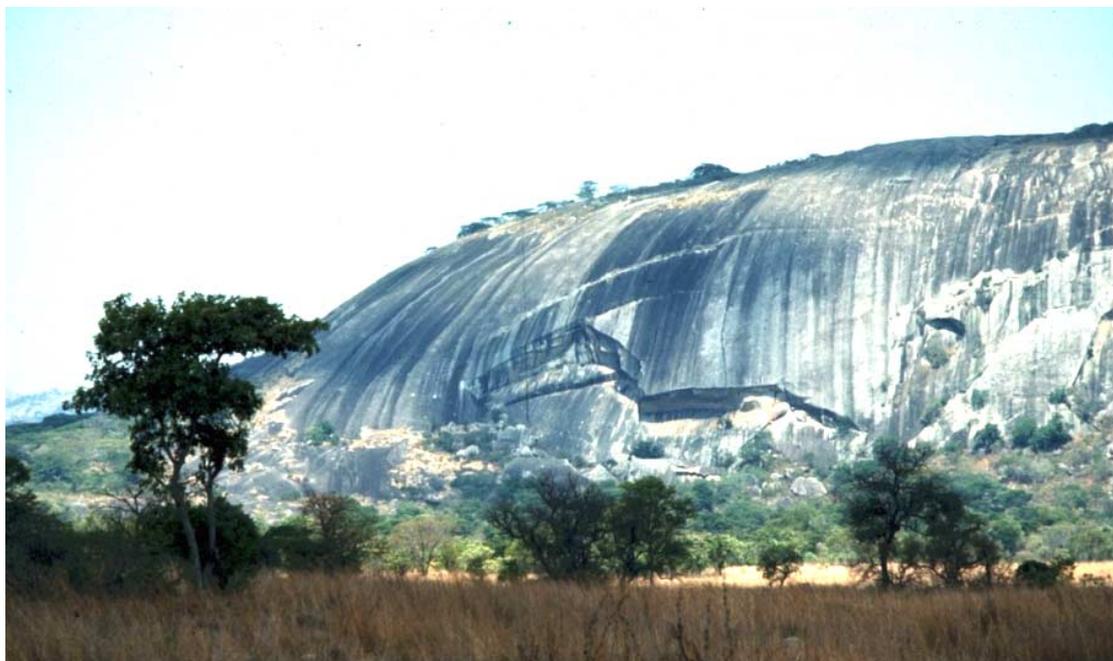
The rock mass in which the slope adjacent to the Sau Mau Ping Road was cut is an unweathered granite with exfoliation or sheet joints similar to those illustrated in Figure 7.2. These joints are parallel to the surface of the granite and the spacing between successive joints increases with increasing distance into the rock mass. Undercutting of these sheet joints can cause a rock slide such as that illustrated in Figure 7.3.

Figure 7.2: Sheet jointing in granite. These features, sometimes referred to as 'onion skin' joints, are the result of exfoliation processes during cooling of the granite.

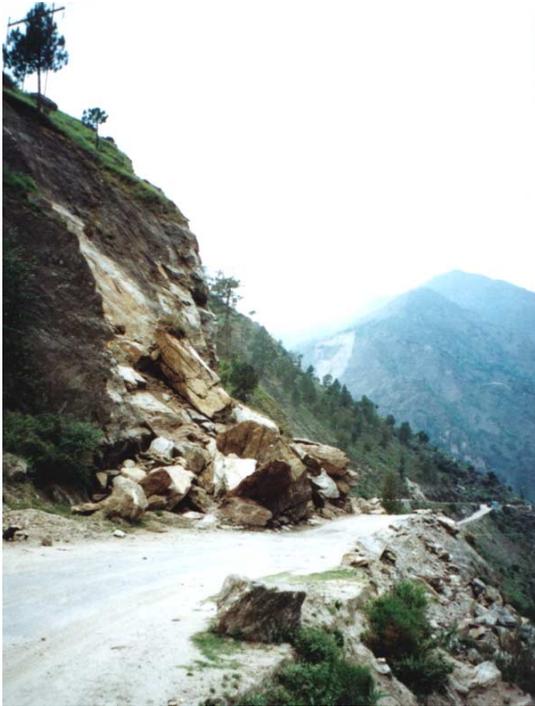
Figure 7.3: A rock slide on a road caused by the undercutting of sheet joints in a granite slope. In hard rocks such as granite, failure can occur very suddenly if the factor of safety of the slope is close to 1. A rise in groundwater levels during a heavy storm or ice jacking in winter may be sufficient to induce failure.

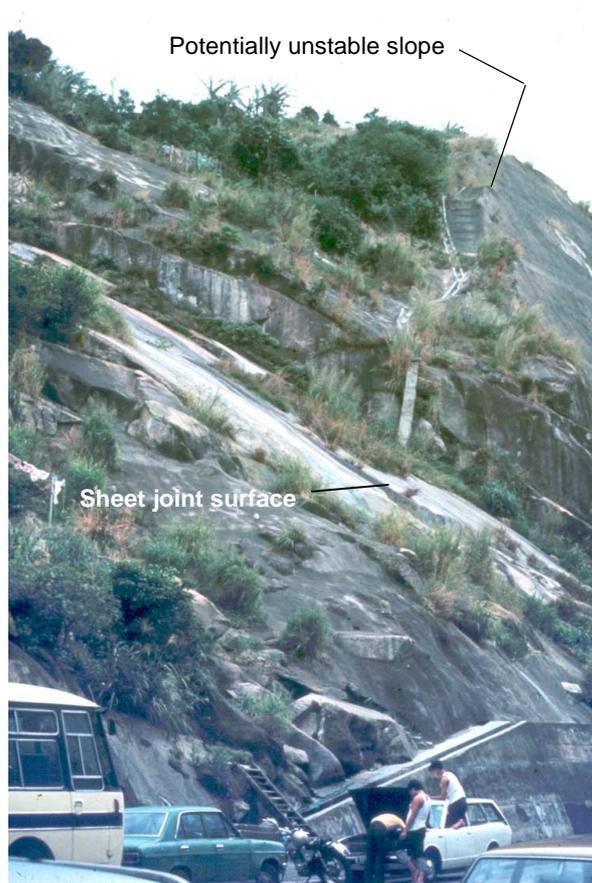
During excavation of the original slopes for the Sau Mau Ping Road, a small rock slide was induced by blasting. The surface on which this failure occurred is illustrated in Figure 7.4. Blasting, such as that used in civil construction in an urban environment, does not impose very large loads on rock slopes and it can be assumed that the factor of safety of the slope was close to unity.

Figure 7.4: The failure surface defined by a sheet joint surface on which a small slide occurred during blasting of the original cut slope for the Sau Mau Ping Road. The potentially unstable slope under consideration is visible in the back-ground.

The potentially unstable slope under consideration is visible in the background of this photograph. It is obvious from this photograph that the sheet joint surface continues under the potentially unstable slope. Hence, from the evidence of the small scale failure, it can be deduced that the factor of safety of the slope in question is not very high.

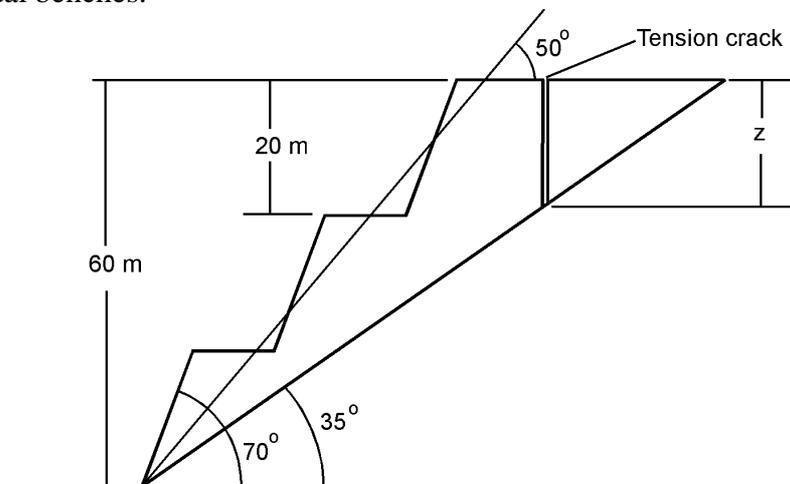
The geometry of the slope is illustrated in Figure 7.5 which shows a 60 m high slope with three 20 m high benches. The overall slope angle is 50° and the individual bench faces are inclined at 70° to the horizontal. An exfoliation joint surface dips at 35° and undercuts the slope as shown in the figure. The slope face strikes parallel to the underlying exfoliation surface and hence the slope can be analysed by means of a two-dimensional model.

Figure 7.5: Geometry assumed for the two-dimensional analysis of the Sau Mau Ping Road slope.

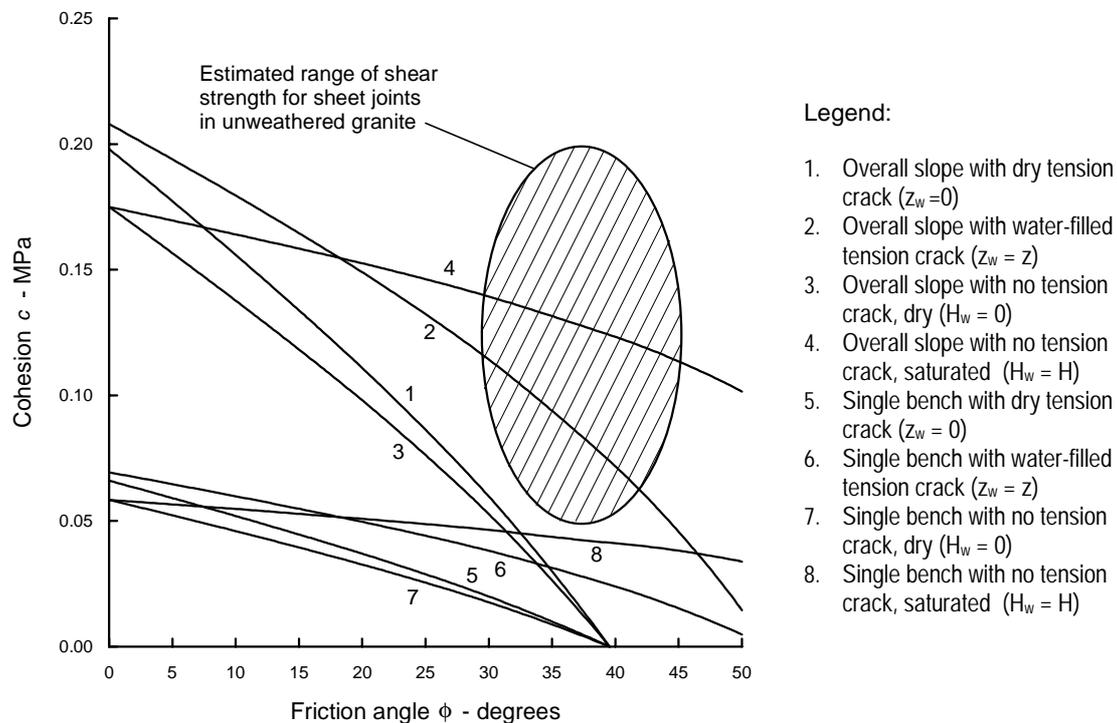
Figure 7.9 shows that only two of the cases analysed result in conditions where the shear strength mobilised at failure falls within the estimated range of available shear strength. These two cases are designated 2 and 4 and they are for fully saturated slopes, with and without tension cracks.

From the results of the sensitivity study described above it was concluded that instability of this particular slope could occur if the slope was fully saturated and subjected to earthquake loading. Typhoons occur several times every year in Hong Kong and the intensity of precipitation during these events is certainly sufficient to saturate the slopes. As discussed earlier, minor earthquakes do occur in the region but they are not very frequent. Consequently, the chance of simultaneous saturation and earthquake loading was considered to be small and it was concluded that there was no serious short-term threat of instability of the Sau Mau Ping slope.

Figure 7.9: Comparison of the shear strength mobilised by failure under various conditions with the estimated shear strength available on sheet joints in unweathered granite.

1. No evacuation of the residents of the two apartment blocks, located across the street from the slope in question, would be carried out.
2. Horizontal drainage holes would be drilled into the slope face to penetrate the potential failure surface in an attempt to reduce uplift pressures in the slope.
3. Piezometers would be installed in holes drilled from the top of the slope. These piezometers would be measured regularly during periods of significant rainfall and the road would be closed to traffic if water levels rose to levels decided by the engineers responsible for the project.
4. An investigation would be carried out into the most effective remedial measures to stabilise the slope for the long-term.

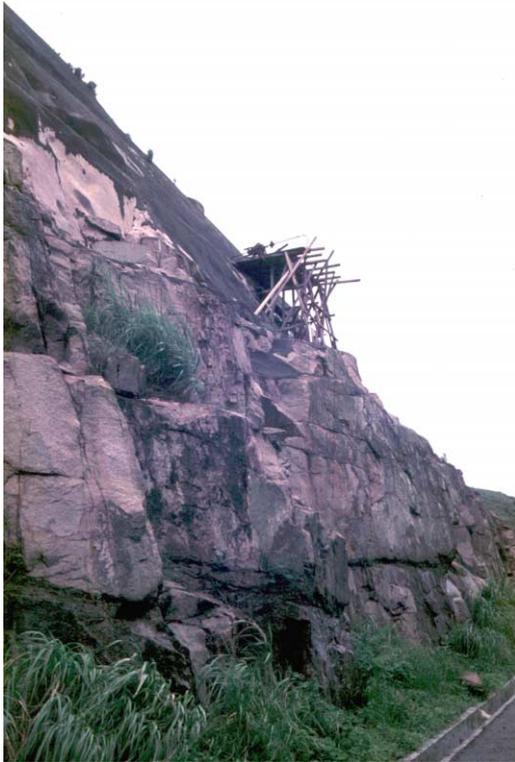
Figure 7.10: Drilling horizontal drain holes into the face of one of the benches of the Sau Mau Ping slope.

Figure 7.10 shows the drilling of the horizontal drain holes into the slope face and Figure 7.11 shows the drilling of the vertical holes into which the piezometers were installed. These piezometers were monitored for the next few years, while preparations for the final stabilisation of the slope were made, and the road was closed to traffic on two occasions when water levels were considered to be dangerously high.

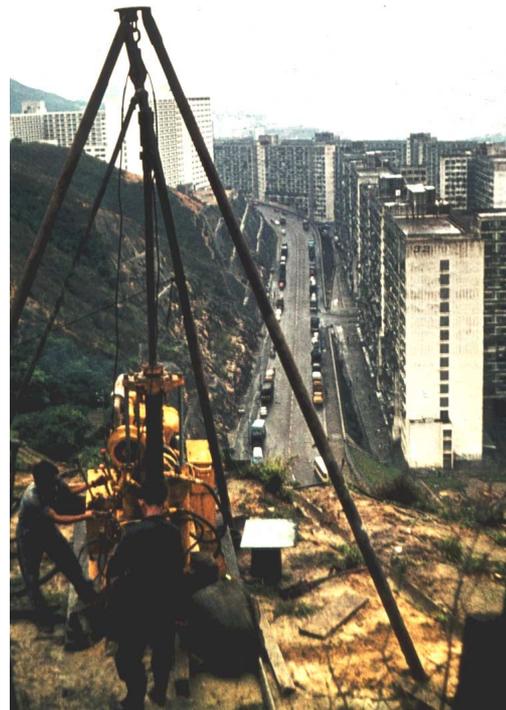
Figure 7.11: Drilling vertical diamond core holes into the Sau Mau Ping slope. These holes were used for geotechnical investigation purposes and also for the installation of piezometers in the rock mass.

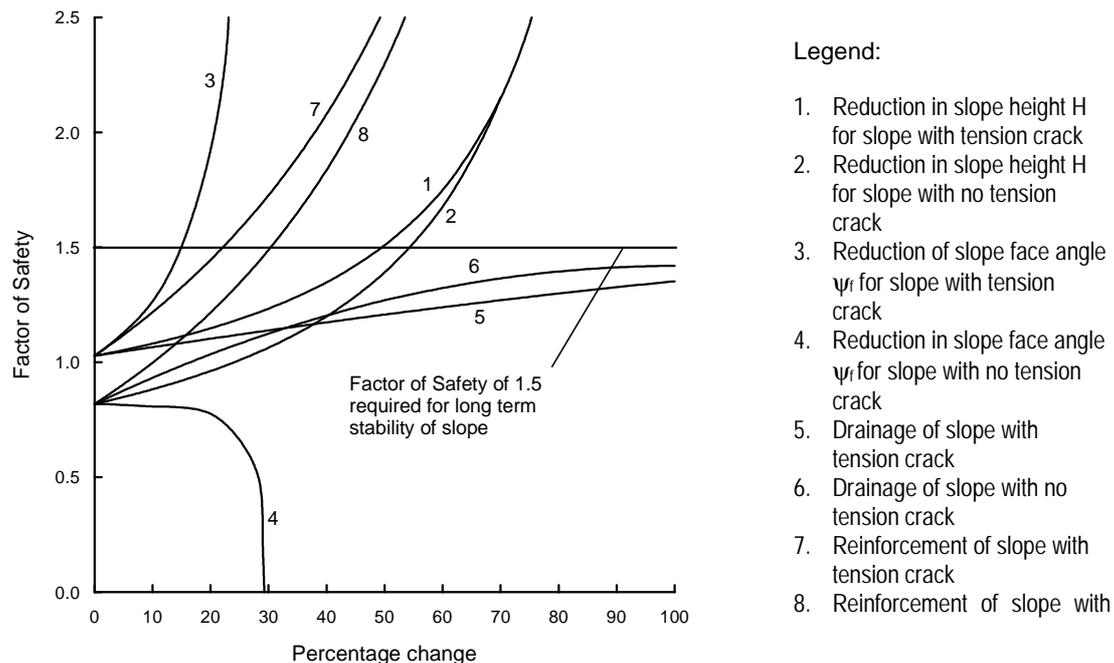
Figure 7.12: Evaluation of remedial options to increase the stability of the slope

- Curves 1 (slope with tension crack) and 2 (slope without tension crack) show that reduction of the slope height is not an effective solution to the problem. In order to achieve the required factor of safety of 1.5, the slope height would have to be reduced by 50%. If this solution were to be adopted, it would be more practical to excavate the entire slope since most of the volume of the rock to be excavated is contained in the upper half of the slope.
- Curve 3 (slope with tension crack) shows that reduction of the slope angle is a very effective remedial measure. The required factor of safety of 1.5 is achieved

for a reduction of less than 25% of the slope angle. In other words, a reduction of the overall slope face angle from 50° to 37.5° would achieve the desired result. This finding is generally true and a reduction in the face angle of a slope is usually an effective remedial step. In the case of slopes under construction, using a flatter slope is always one of the prime choices for achieving greater stability.

- Curve 4 (slope without tension crack) is an anomaly and demonstrates that calculations can sometimes produce nonsense. The reduction in factor of safety shown by this curve is a result of the reduction in the weight of the sliding block as the face angle is reduced. Since the water pressure on the sliding surface remains constant, the *effective stress* acting on the sliding surface decreases and hence the frictional component of the resisting forces decreases. When a very thin sliver of rock remains, the water pressure will float it off the slope. The problem with this analysis lies in the assumption that the block is completely impermeable and that the water remains trapped beneath the failure surface. In fact, the block would break up long before it floated and hence the water pressure acting on the failure plane would be dissipated.

- Curves 5 and 6 show that drainage is not a very effective option for either of the slope models considered. In neither case is a factor of safety of 1.5 achieved. This is something of a surprise since drainage is usually one of the most effective and economical remedial measures. The reasons for the poor performance of drainage in this case is due to the combination of the geometry of the slope and the shear strength of the failure surface.

- Curves 7 and 8 show that, for both slope models considered, slope reinforcement by means of rockbolts or cables can be an effective remedial measure. The anchor force required for a factor of safety of 1.5 would be about 100 tonnes per metre of slope length for the slope with no tension crack.

The two most attractive options for long term remedial works on this slope are reinforcement by means of cables or bolts or reduction of the slope face angle. The first option was finally rejected because of the high cost and because of the uncertainty about the long term corrosion resistance of reinforcement which could be placed in the slope. This latter concern may not have been justified but, considering the very poor quality of some of the construction in Hong Kong at the time of this study, it was decided that the risk was not worth taking.

The option finally chosen was to reduce the slope face angle down to 35° by excavating the entire block resting on the failure surface and hence removing the problem entirely. Since good quality aggregate is always required in Hong Kong it was decided to work this slope face as a quarry. It took several years to organise this activity and, during this time, the water levels in the slope were monitored by means of piezometers. Although the road was closed twice during this period, no major problems occurred and the slope was finally excavated back to the failure plane.
