A slope stability problem in Hong Kong

7.1 Introduction

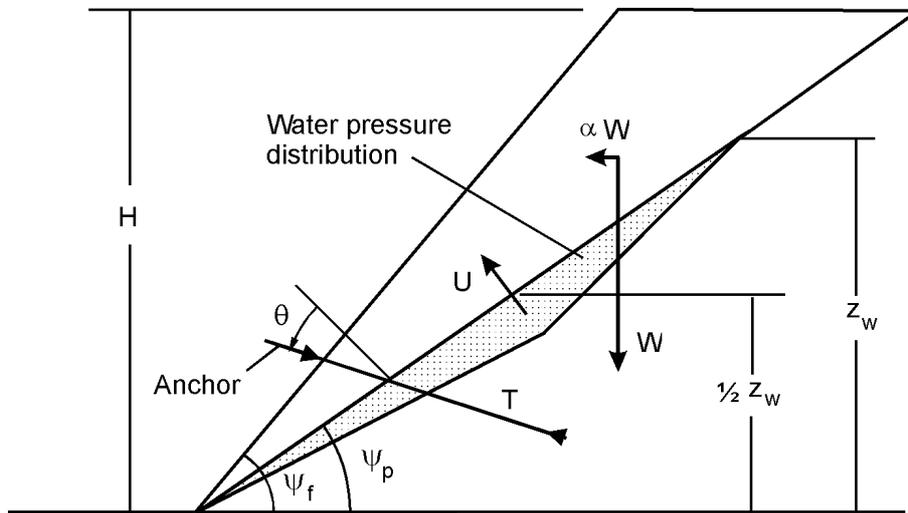
Figure 7.6: Factor of Safety calculation for a slope with no tension crack.

The traditional method of incorporating the acceleration induced by earthquakes or large blasts in slope stability analyses is to add an outward force αW to the forces acting on the slope (see Figure 7.6 and Figure 7.7), where α is the acceleration as a proportion of g , the acceleration due to gravity. This 'pseudo-static' form of analysis is known to be very conservative but, in the case of the Sau Mau Ping slope, this conservatism was not considered to be out of place.

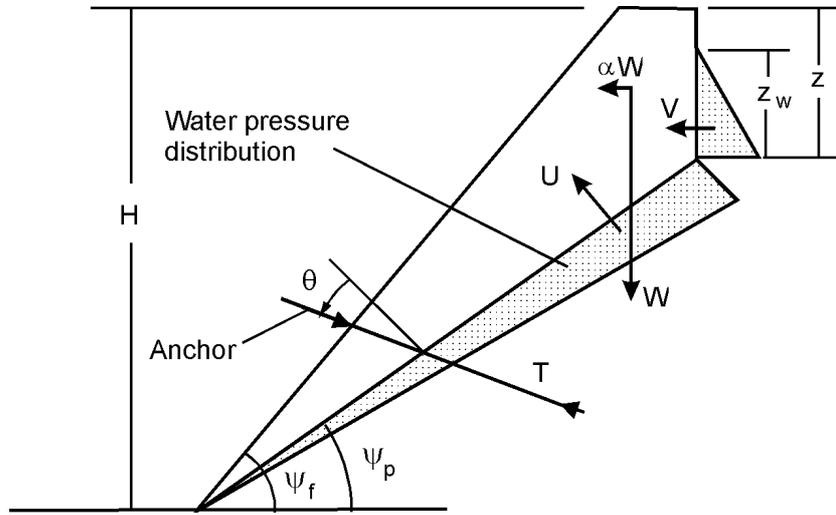
Figure 7.7: Factor of Safety calculation for a slope with a water-filled tension crack.

In Figure 7.7, the depth z of the tension crack is calculated by equation 7.6. This equation is obtained by minimising equation 7.5 with respect to the tension crack depth z (Hoek and Bray 1974). This minimisation is carried out for a dry slope and the accuracy of equation 7.6 decreases as the water depth in the tension crack increases. However, for the purposes of this analysis, the estimate given by equation 7.6 is considered acceptable.

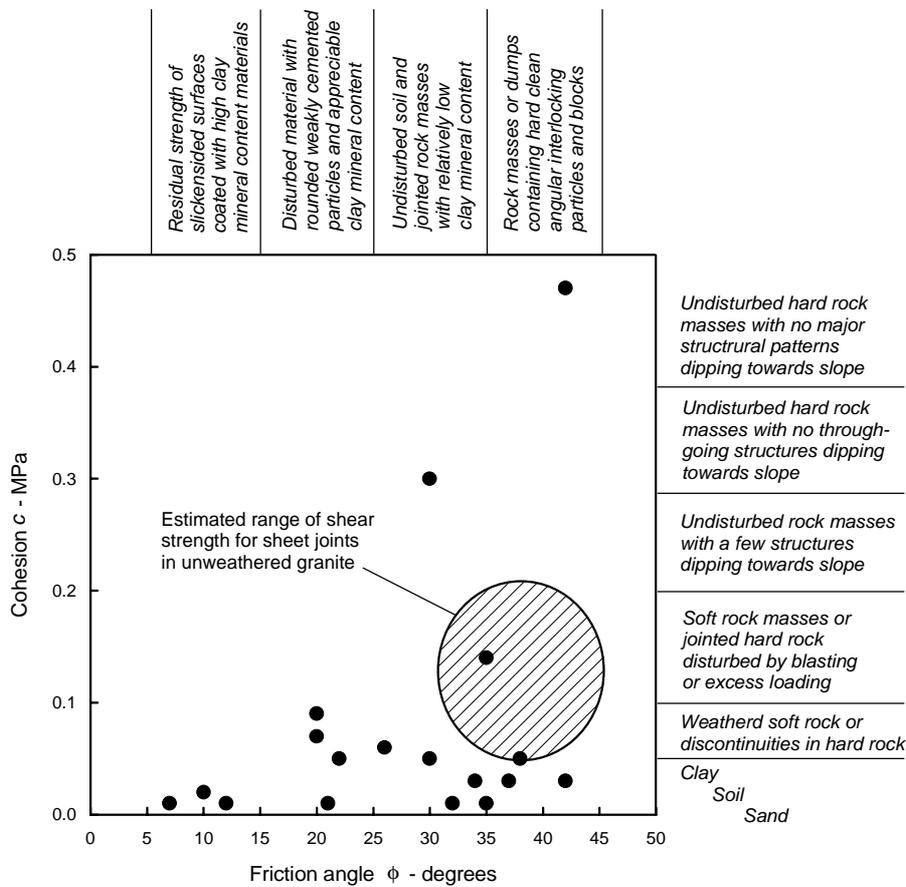
back analysis of slope failures. Superimposed on this plot is an elliptical zone which encompasses the estimated range of shear strength for sheet joints in unweathered granite. In choosing this range it was considered that the friction angle ϕ probably ranges from 30° for very smooth planar surfaces to 45° for rough or partly cemented surfaces. The cohesive strength c is more difficult to estimate and the range of 0.05 to 0.2 MPa was chosen on the basis of the results of back-analyses of slope failures, plotted in Figure 7.8.

Figure 7.8: Relationship between friction angles and cohesive strengths mobilised at failure of slopes in various materials. The plotted points were obtained from published information from the back analysis of slope failures. (After Hoek and Bray 1974).
